ATLAS ASBESTOS MINE Fresno County, California

COALINGA ASBESTOS MINE Fresno County, California

ATLAS/COALINGA ASBESTOS MINE SITES RI/FS

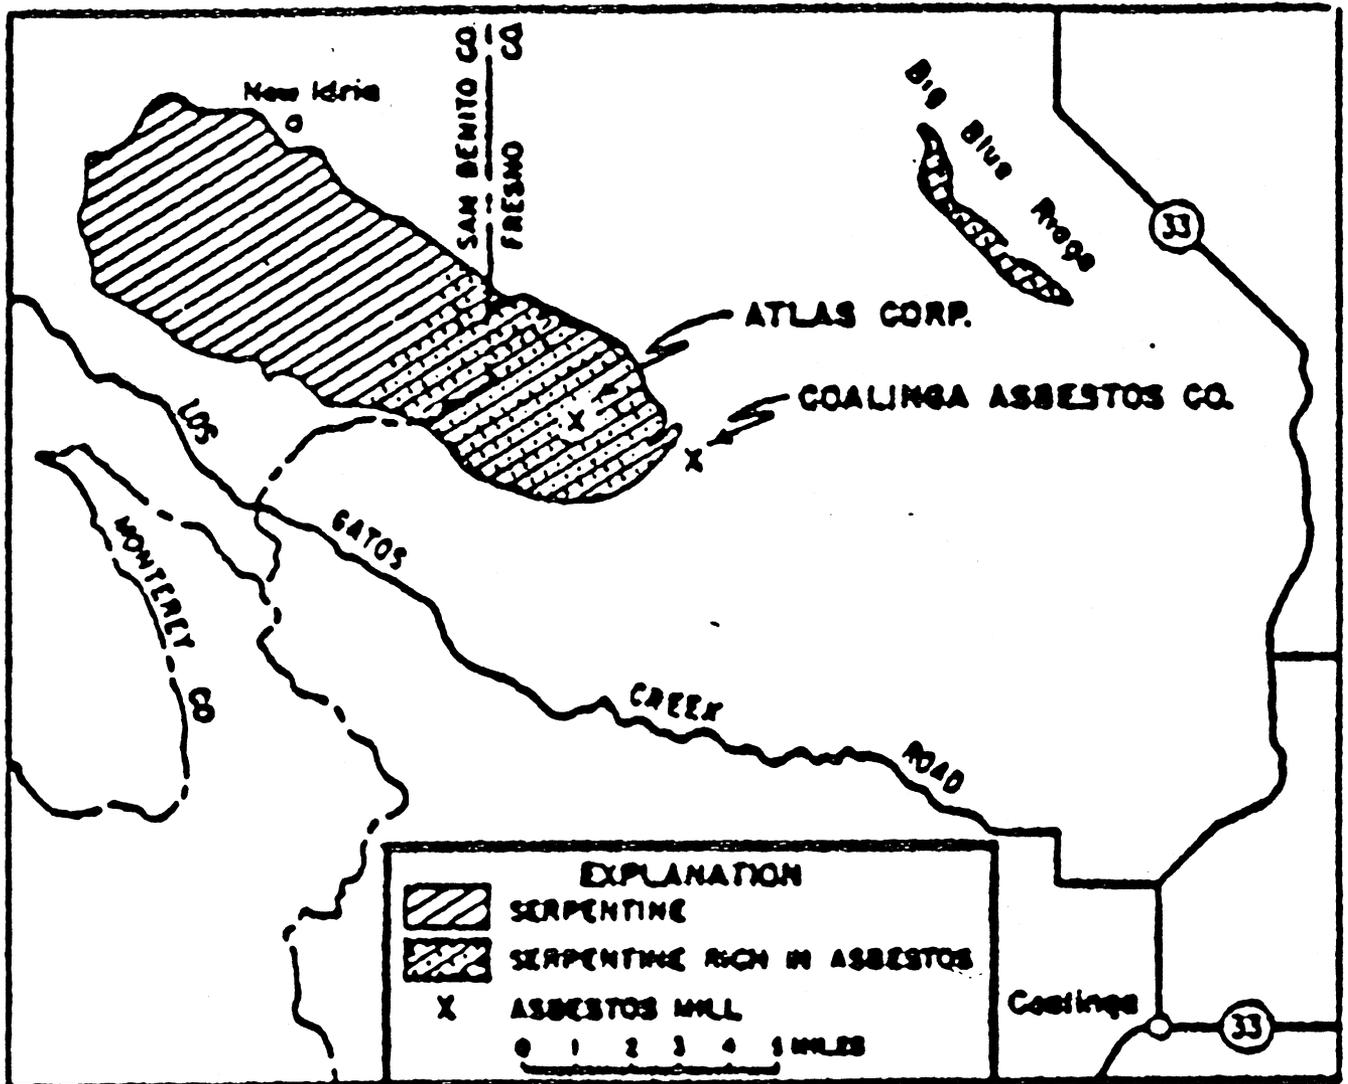
Figure 3.17

Index map to asbestos deposits and mills in the vicinity of Coalinga, Fresno County.

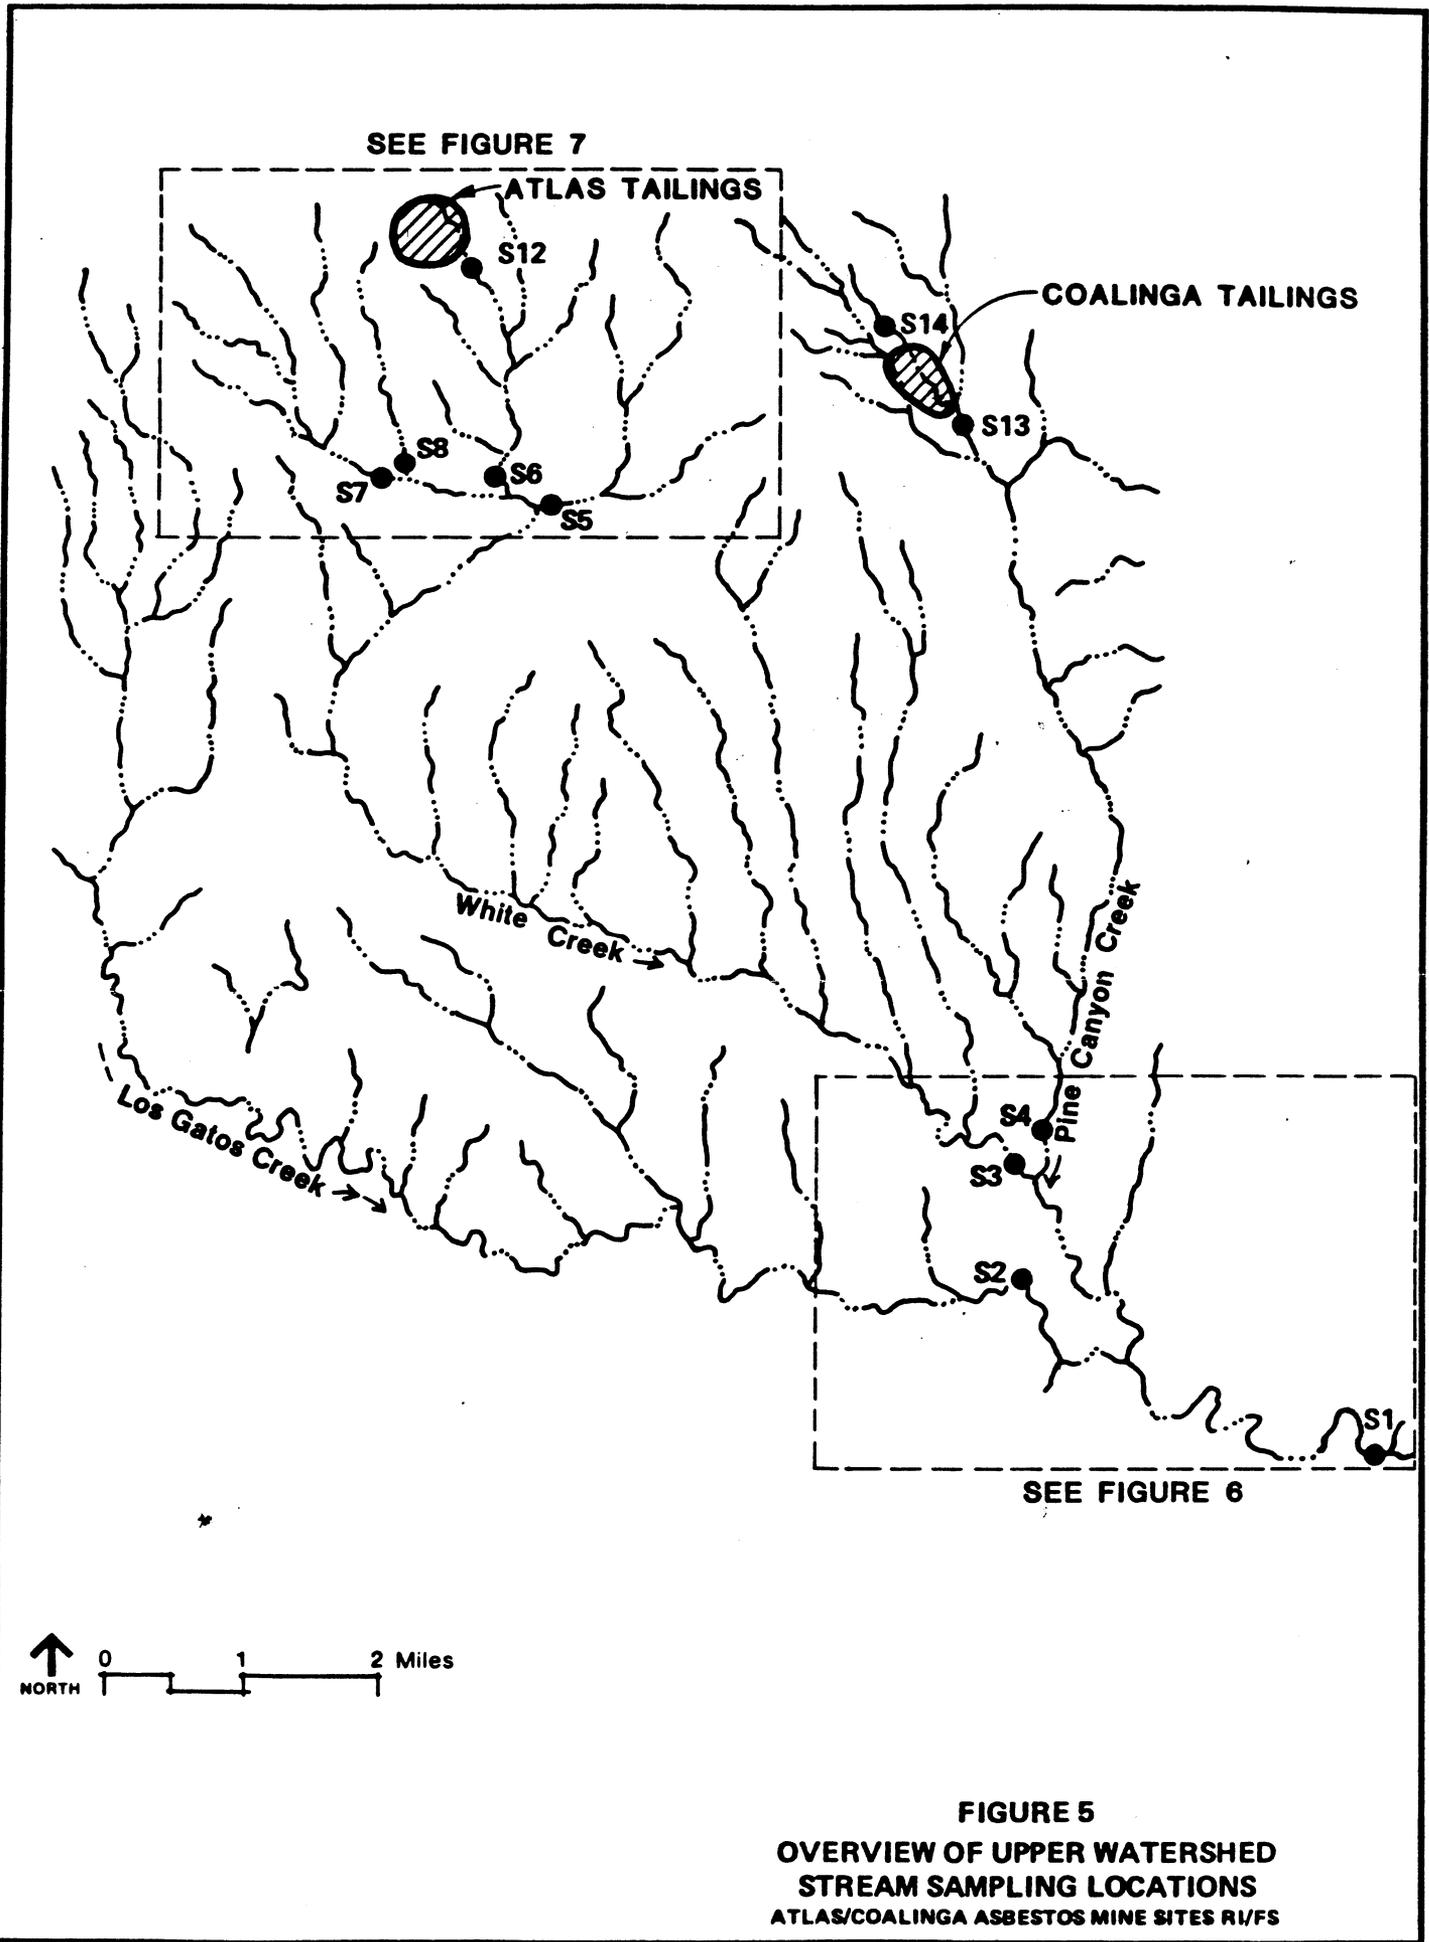
FIGURE 5
OVERVIEW OF UPPER WATERSHED
STREAM SAMPLING LOCATIONS
ATLAS/COALINGA ASBESTOS MINE SITES R1/FS

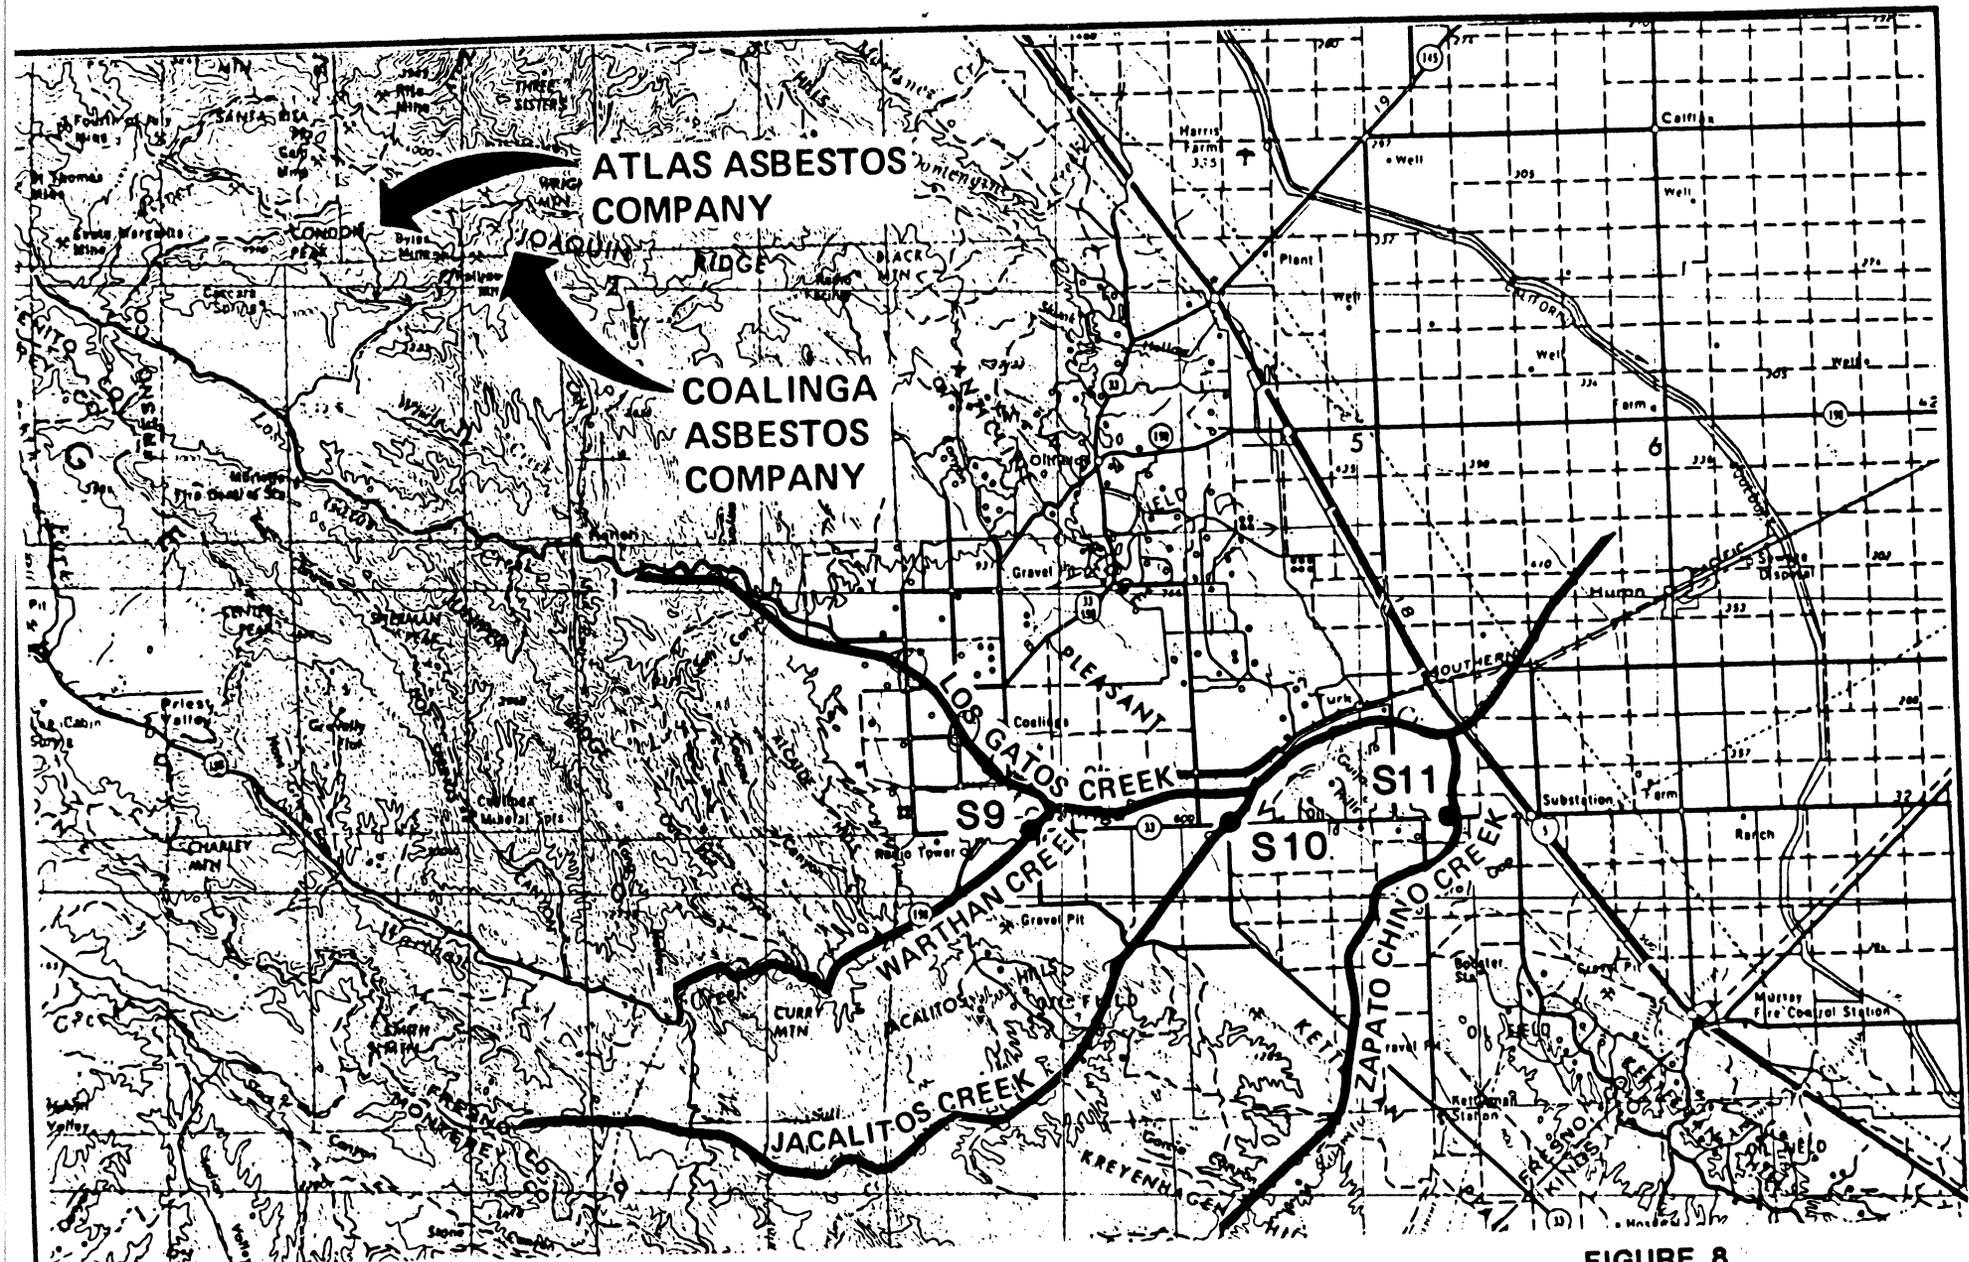
FIGURE 8

S10 SAMPLE LOCATION

**SURFACE WATER/SEDIMENT
SAMPLING LOCATIONS
LOWER SITES**

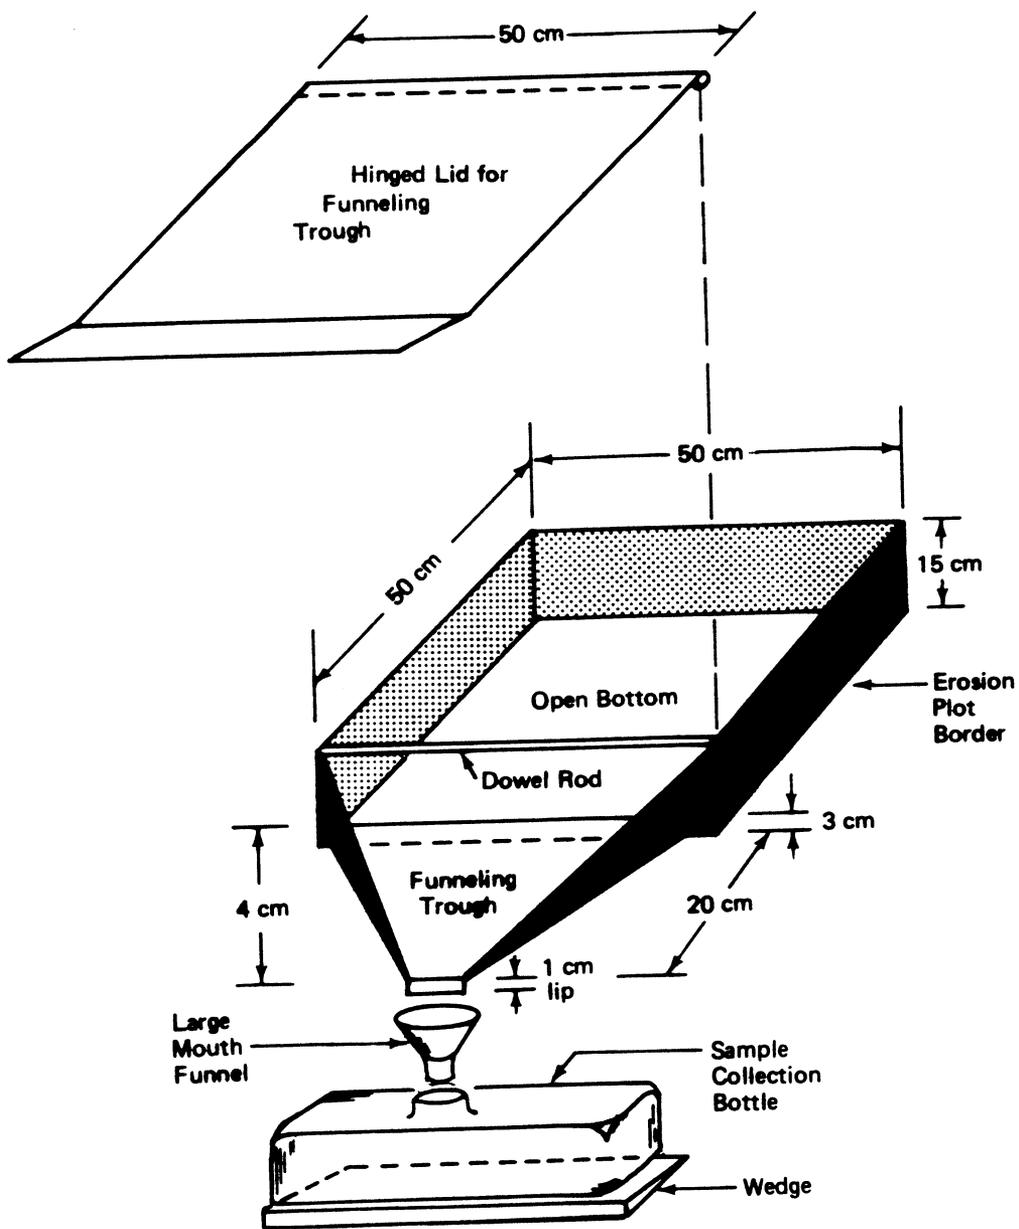
Figure 6-1. EROSION PLOT SAMPLE COLLECTION SYSTEM

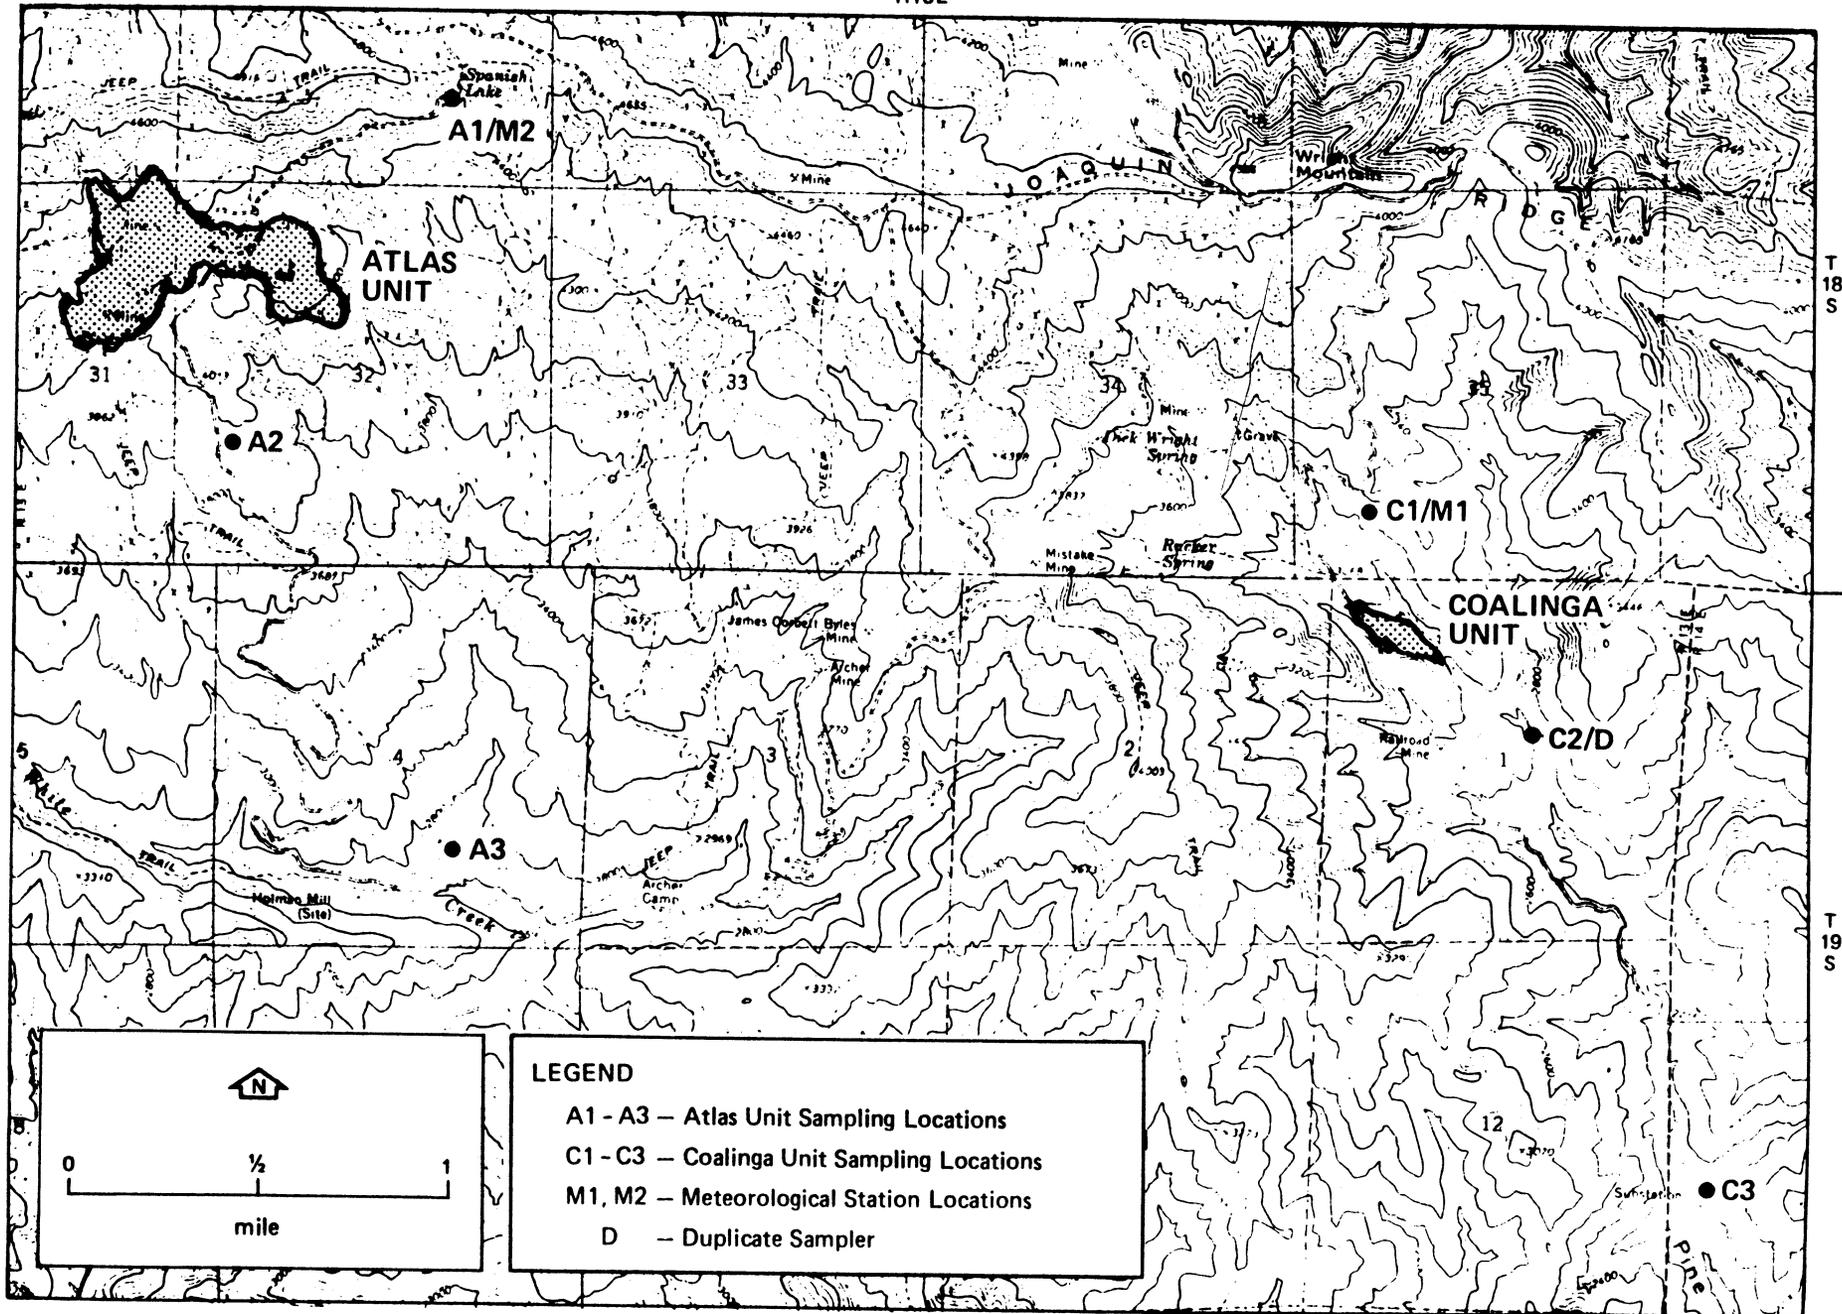
Figure 5.1 PROPOSED AIR ASBESTOS AND METEOROLOGICAL MONITORING SITES

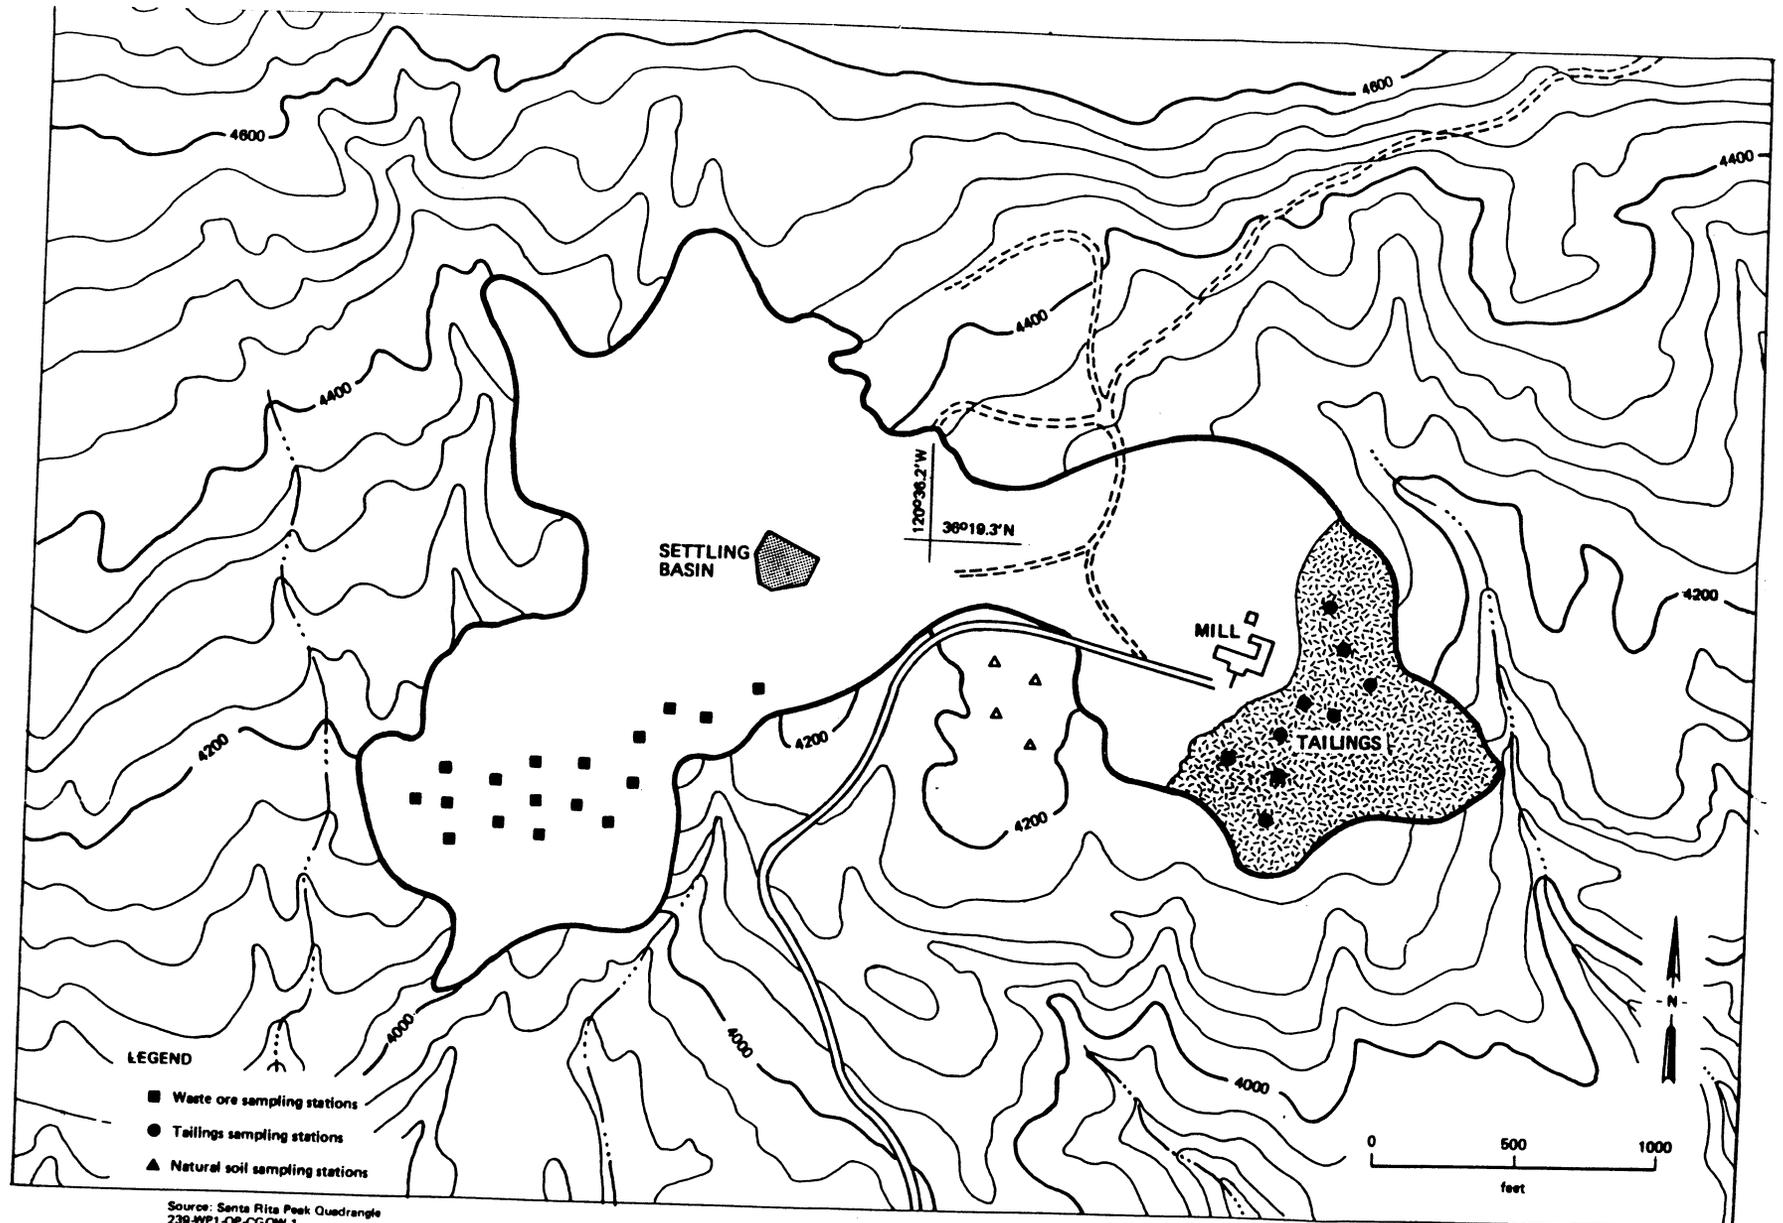
Figure 2-4. LOCATION OF SOIL EROSION PLOT SAMPLING STATIONS AT THE ATLAS SITE

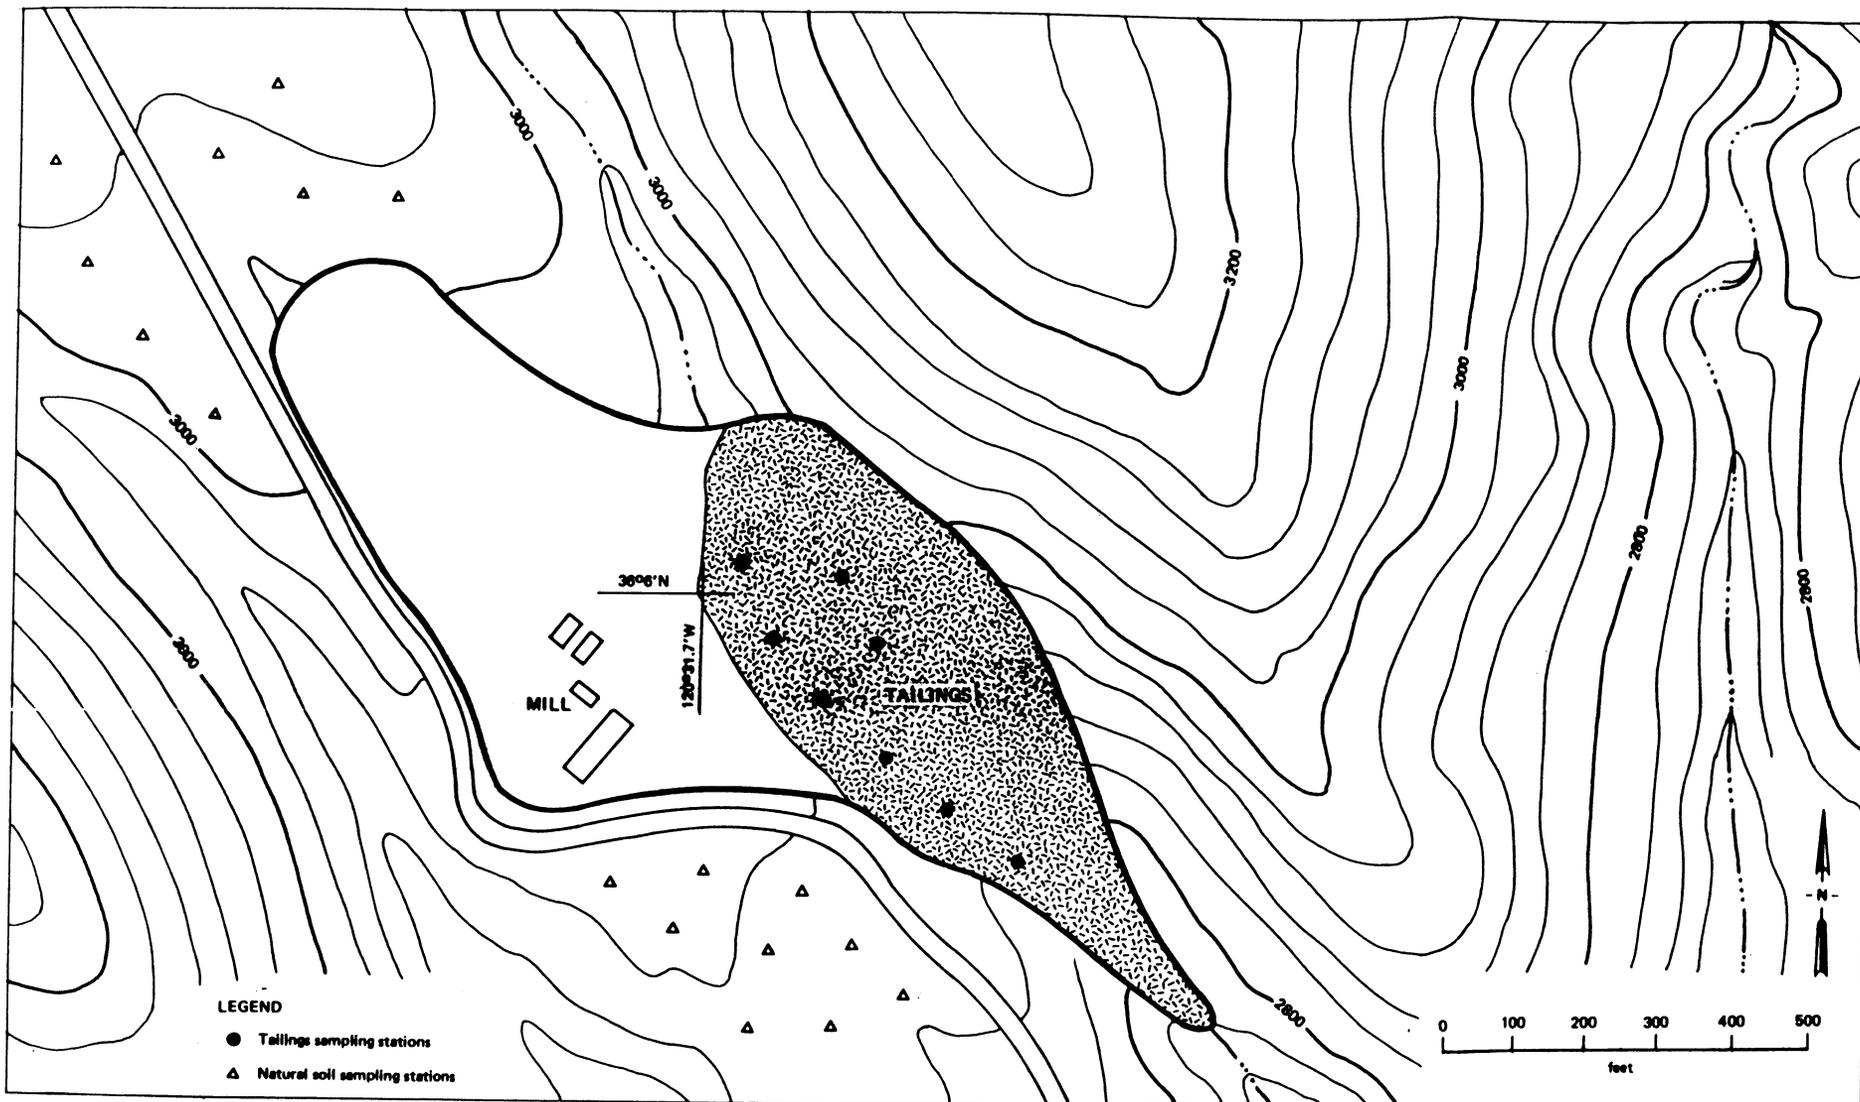
Figure 2-5. LOCATION OF SOIL EROSION PLOT SAMPLING STATIONS AT THE COALINGA SITE

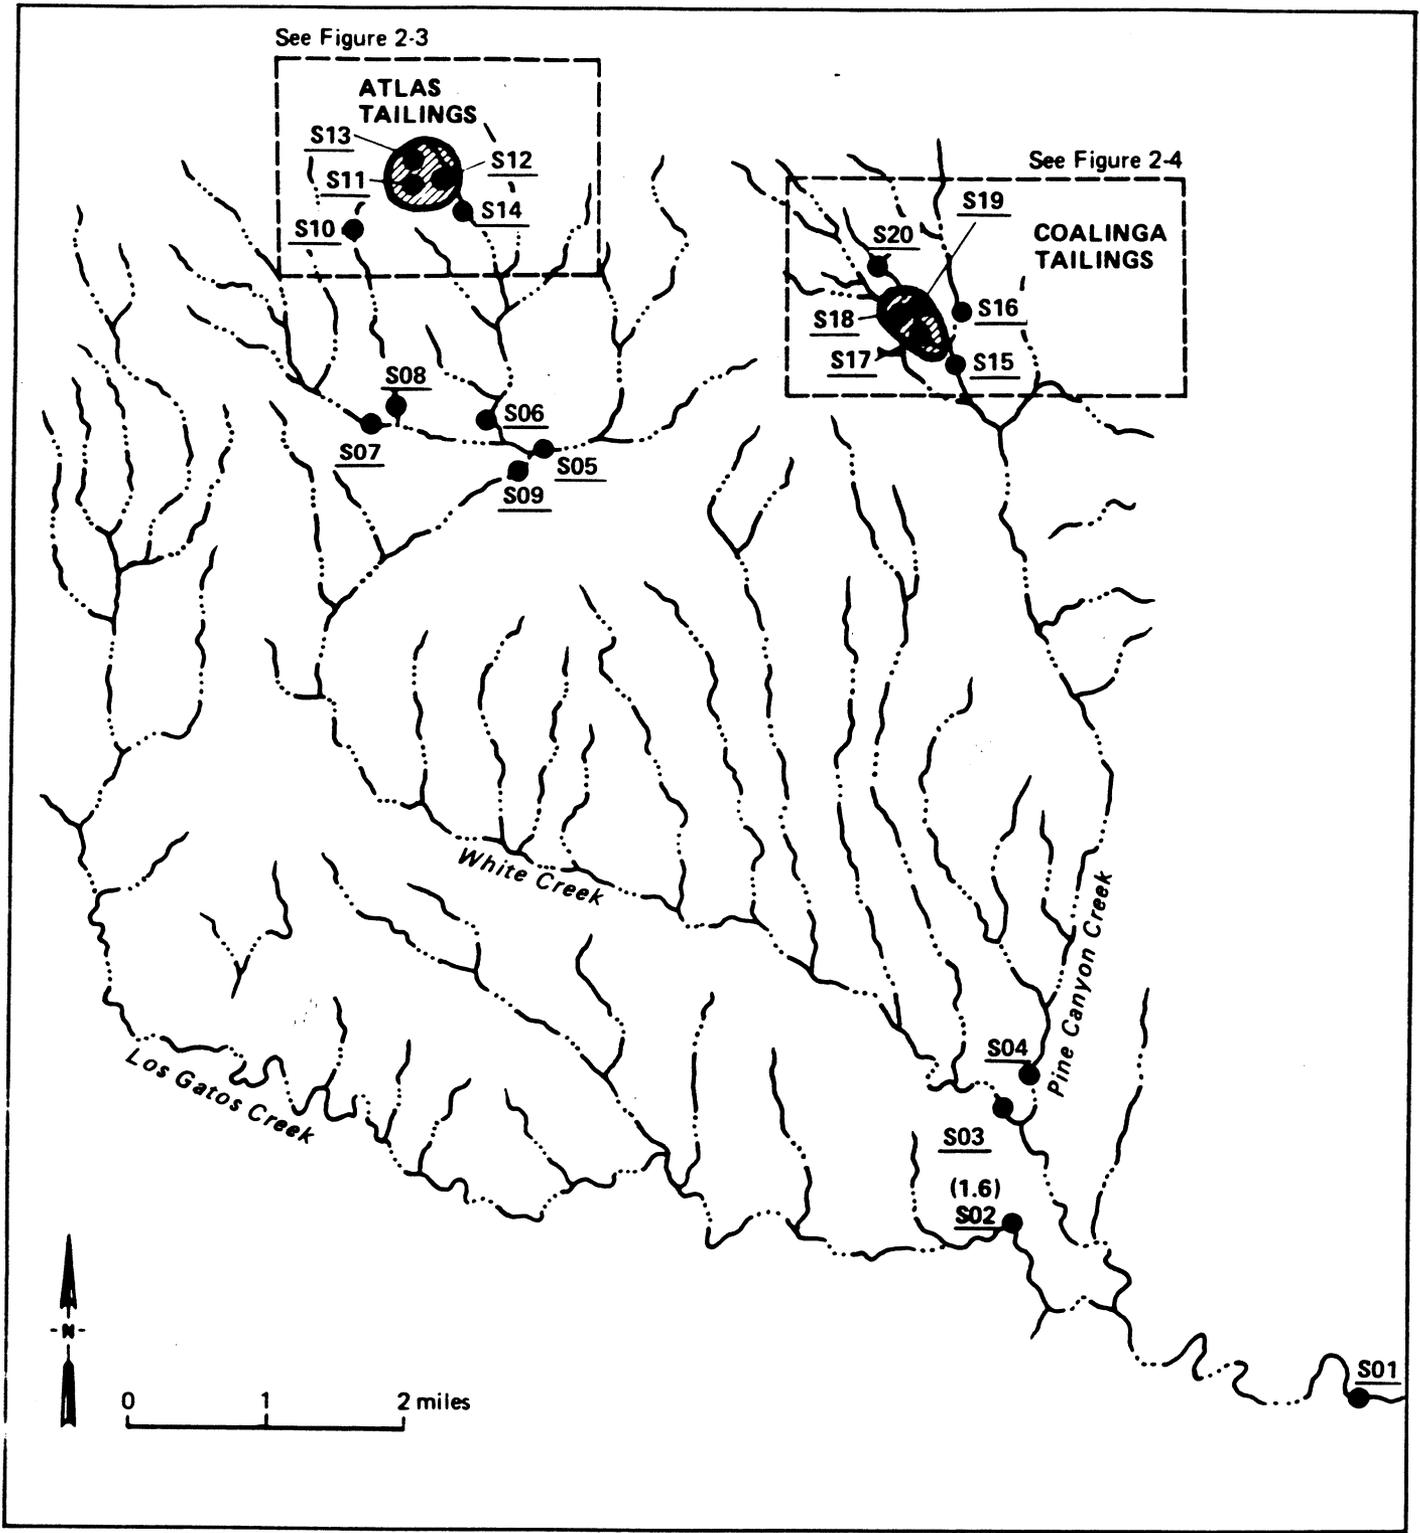
- S12 Water quality sampling station

Figure 2-2. WATER QUALITY SAMPLING STATIONS

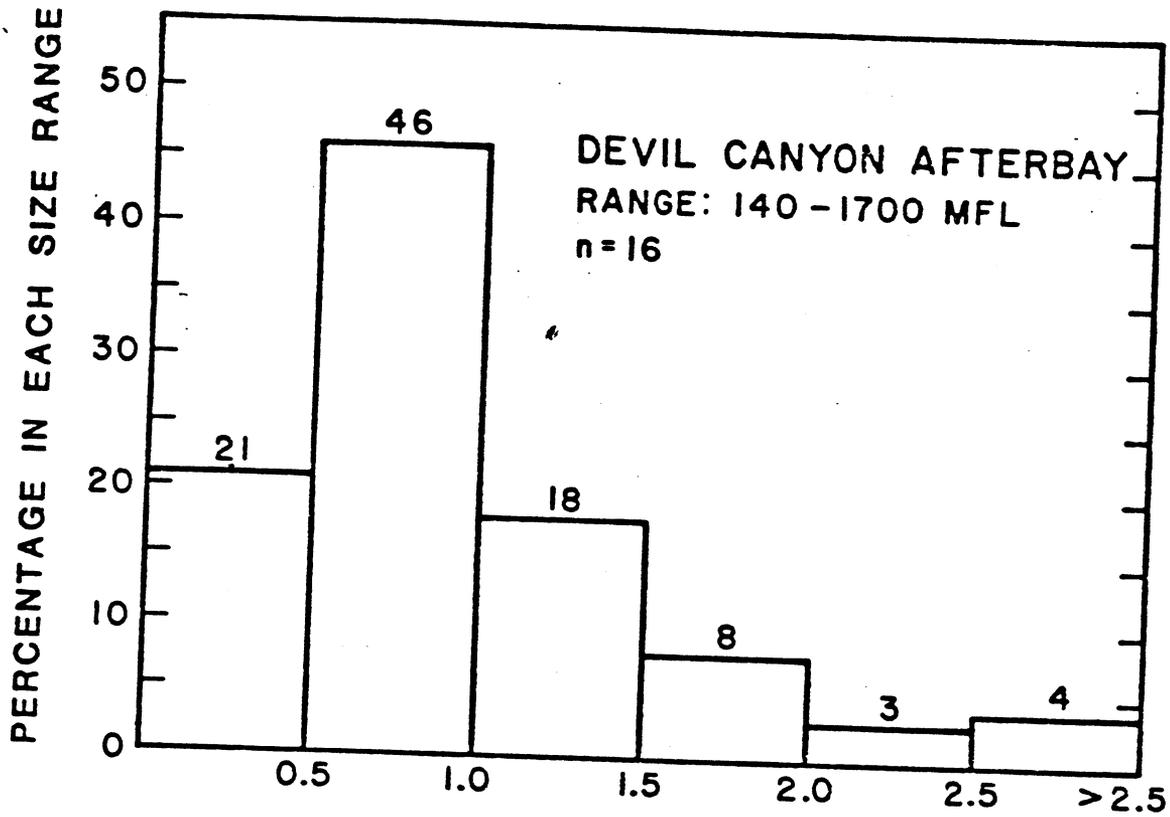
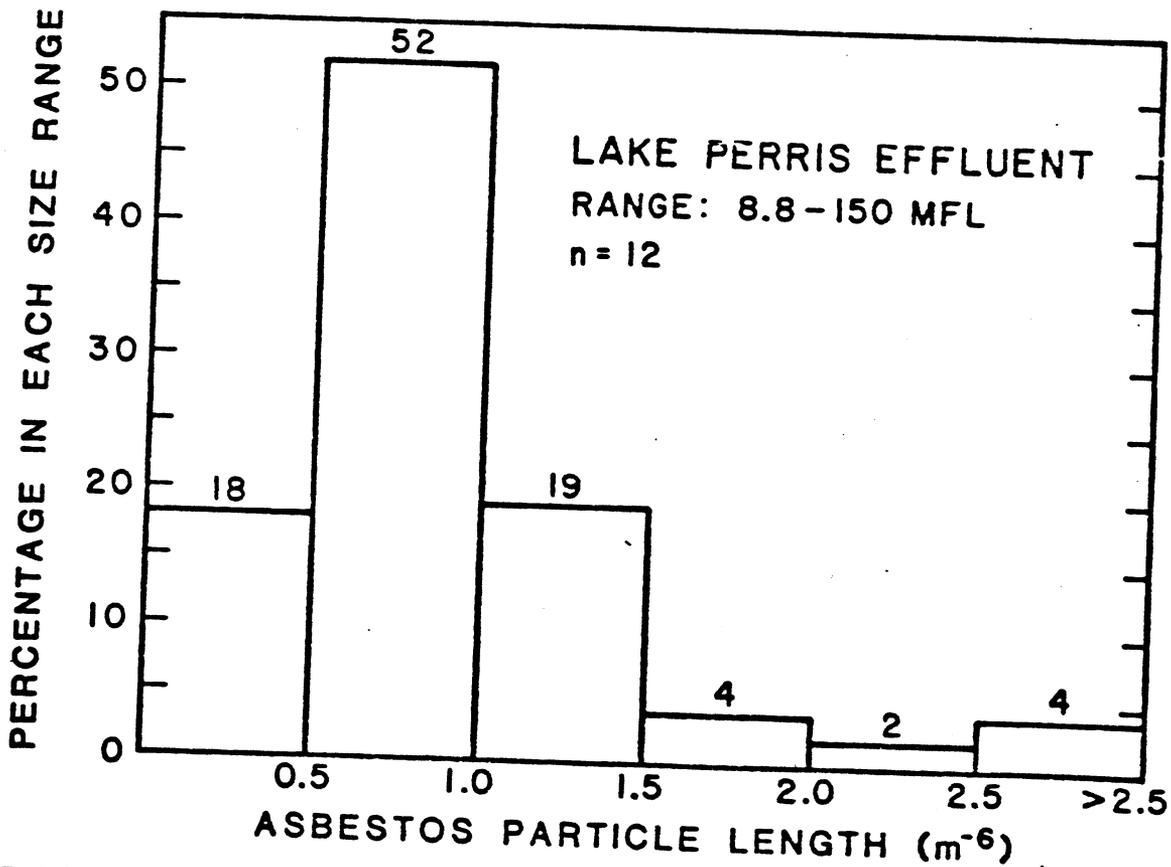
MEAN PARTICLE SIZE DISTRIBUTIONS FOR DEVIL CANYON AFTERBAY AND LAKE PERRIS EFFLUENT
FIGURE 8
